2017 Hurricane Harvey Deployment  
Arkema Facility Response

***2017 ASPECT Preliminary Report  
Arkema Plant Response  
Crosby, TX***

***August 31, 2017  
0600 hrs to 0845 hrs***

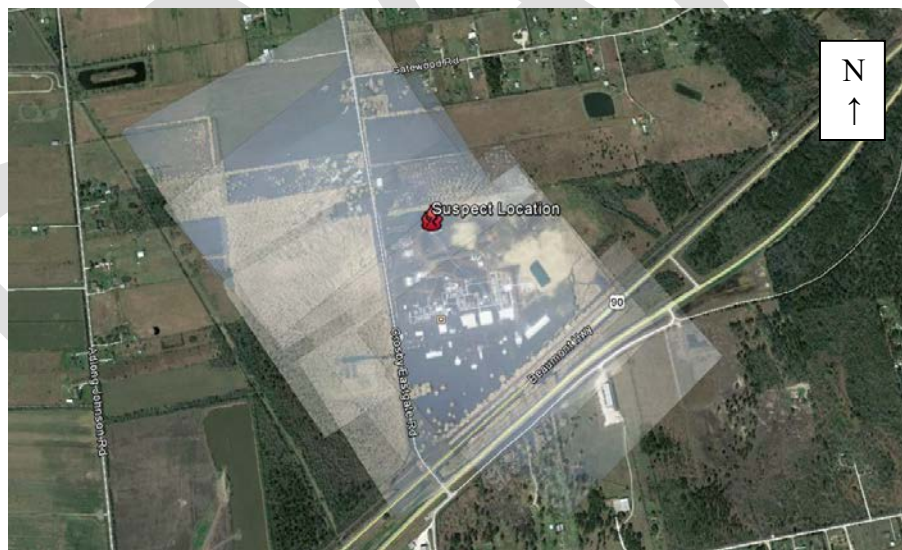
Figures 2 & 3 show a visible image of the facility with no observed plume and the flight path highlighted when IR sensors were active.

*Figure 2: Low resolution aerial images pulled from the aircraft while in flight over the facility, 30 August 2017 at about 0730 hrs CST.*

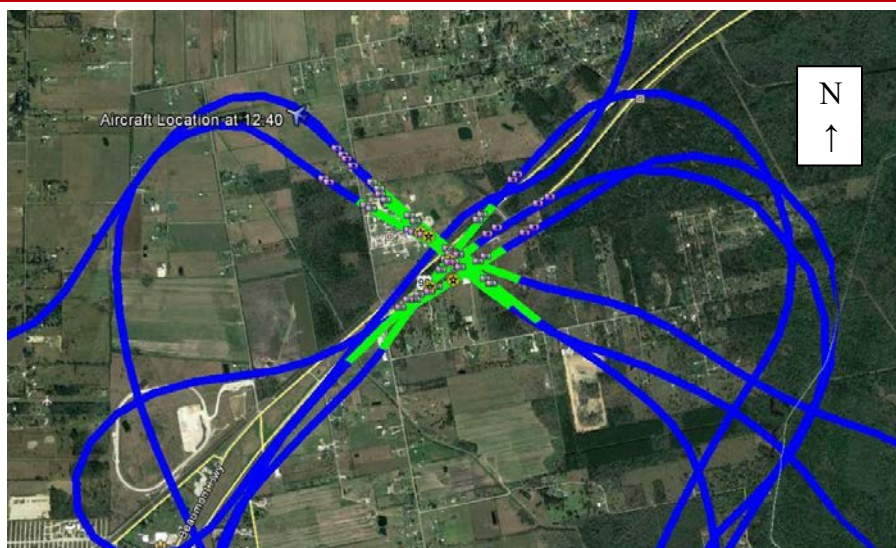
Figure 3: Flight path over the facility at 0731 hr CST (1231 hrs UTC) showing several passes where aerial imagery and IR sensors are active.
